Site Inventory Form
State Historical Society of Iowa
 (December 1, 1999)

historic name Commercial Building
 other names/site number Field Site #: FS-031

street & number 118 Chestnut Street
 city or town Muscatine vicinity, county Muscatine
 Legal Description: (If Rural) Township Name _____ Township No. _____ Range No. _____ Section _____ Quarter of Quarter _____
 (If Urban) Subdivision Original Town Block(s) 10 Lot(s) N23' S61' of Lot 6

Historical and Architectural Survey and Evaluation of the Downtown Commercial District 70-013

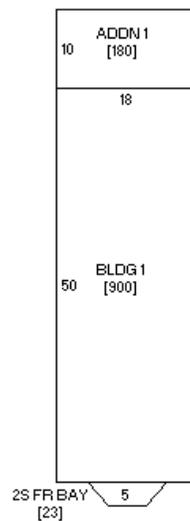
Plan (from assessor's office)

(front - Chestnut)

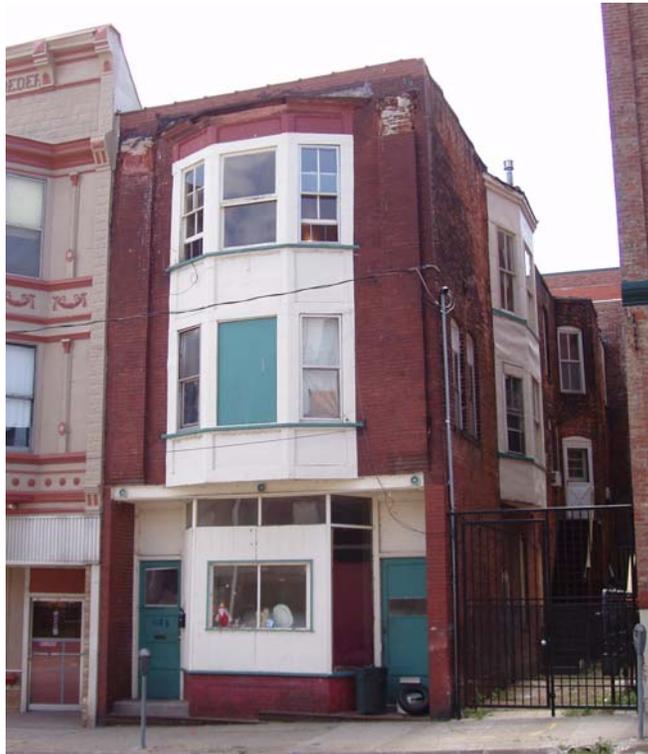
Photograph of building (digital image)

A two-story, oriel window dominates the façade of 118 Chestnut. The oriel window, and a similar unit on the north elevation of the building, first appear on the 1905 Sanborn map, indicating those features were apparently added at the same time many of the other bay windows on downtown buildings were installed. The original building is shown on the 1883 Sanborn, along with two similar three-story buildings immediately to its south. Collectively, the three buildings appear to be a single unit, and an 1875 birds-eye view of Muscatine appears to confirm this. However, the southernmost building, 114 Chestnut, no longer exists. The middle building, 116 Chestnut, has been covered in metal, and a short roof extension might have been added, making a determination that all the buildings were similar in design and age impossible to determine.

The storefront of 118 Chestnut has been altered, but no historic photos could be found to compare its current appearance with any earlier image. It appears that this storefront might date around 1900-05, the same time that the upper oriel window was added. Currently, two recessed entryways are located on each side of an extended center storefront. The storefront has been covered with wood siding, with two smaller fixed sash windows centered in the main front section. A series of four transom windows extend across the front of the protruding center section, including the two angled sides. A steel beam header extends across the storefront. The two-story oriel window has a larger center window and smaller side windows. The second-story has one-over-one-light, double-hung windows on each side, with a boarded up center window. The double-hung sashes on the third-floor windows are two-over-two-light on each side, with a one-over-one-light, double-hung center window. Brick pilasters on each side of the bay windows extend up the façade from the iron beam, but brick at the top of the pilasters have been damaged. The top of the oriel appears to be metal, but there is little additional decorative detail.
